80 MW Turbine-Generator **Journal-Thrust Bearing Upgrade**

TCE/Turbo Components & Engineering

POWERGEN/The Power Generation Company of
Trinidad & Tobago

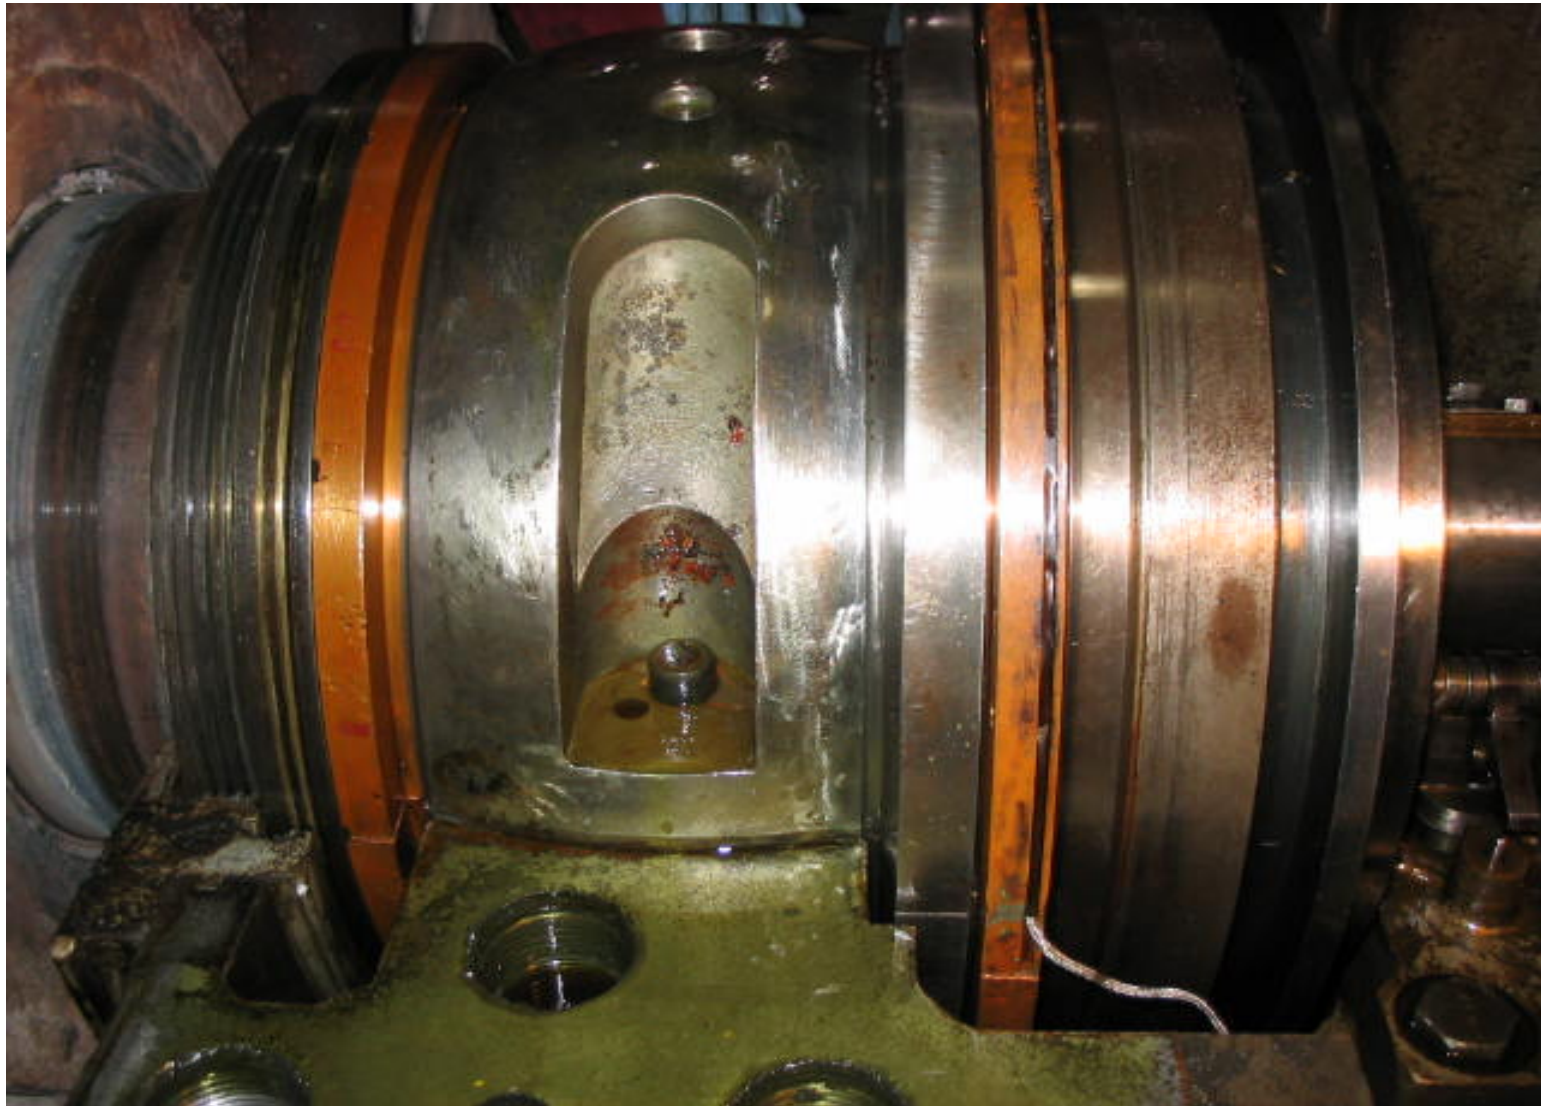
OEM bearing assembly

The original bearing is a spherical fitted combination journal thrust, with taper plates for thrust bearings, and thin sleeve liner for journal bearing.

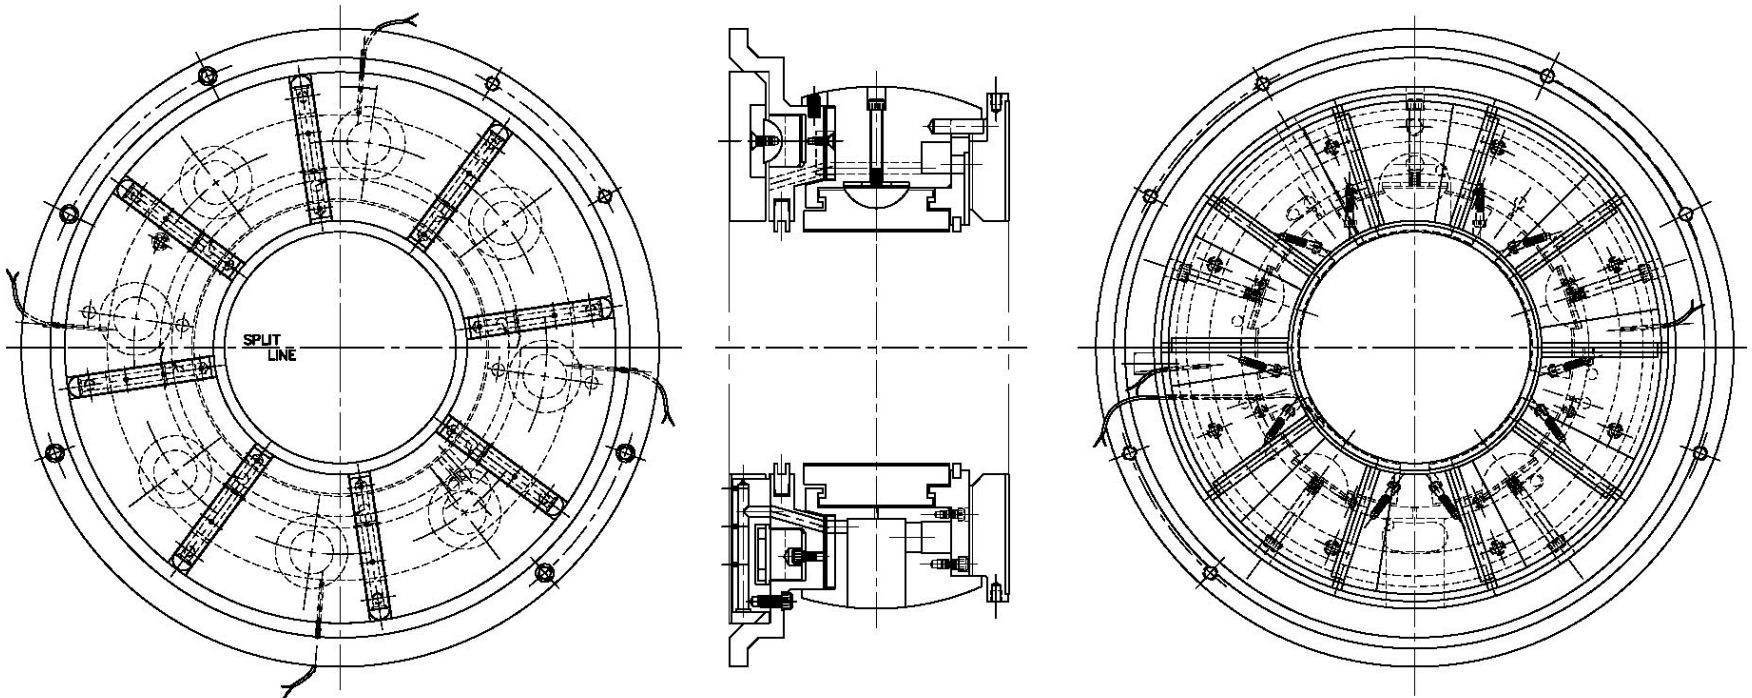
Upgraded Bearing Assembly

A combination journal/thrust assembly was designed and installed in the turbine. This assembly incorporated a fully equalized ball & socket tilting pad thrust bearing with directed lubrication on the active side, the continued use of a taper land plate on the inactive side, and a ball & socket tilting pad journal bearing.

The thrust pads are designed with 65% offset pivot in copper backed pads.

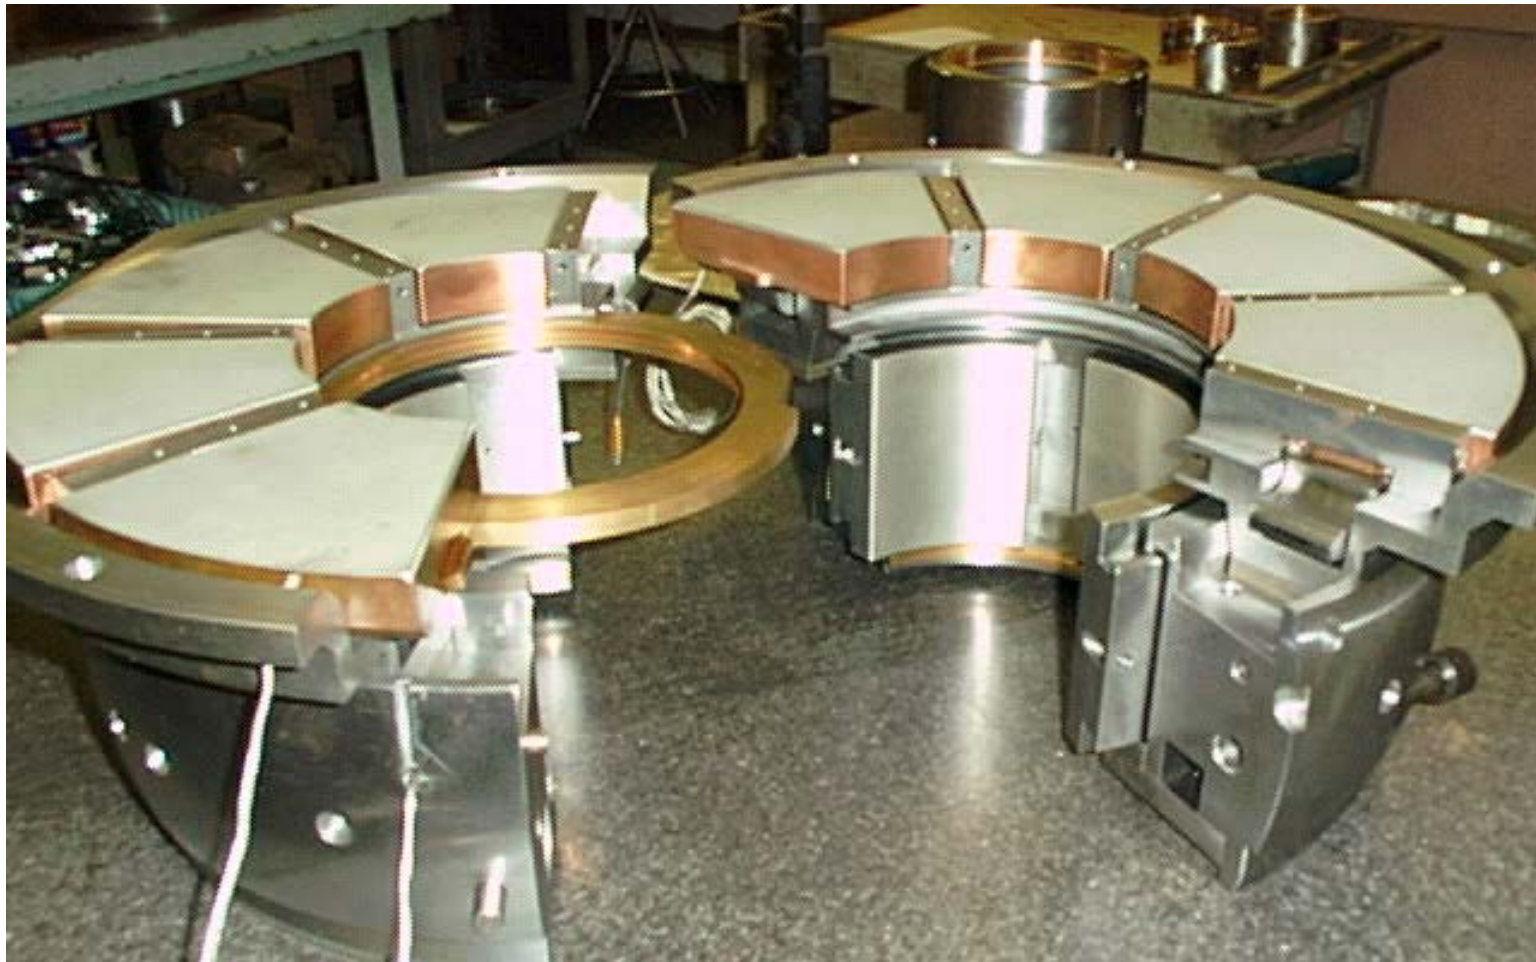
Photograph of upgraded Bearing Assembly

After one year in service, the customer had concerns about the percentage of water in the oil.

The bearing steel thrust bearing surfaces attacked by rust.

The thrust bearing has rusted surfaces in all steel parts.

After cleaning the rust, and light cleaning of the babbitt face, the bearing was installed without any repairs.
